ZAKHO MILITARY ACADEMY  
ZAKHO, IRAQ

**SIGIR PA-06-039**  
**APRIL 12, 2006**

SUBJECT: Report on the Project Assessment of the Zakho Military Academy, Zakho,  
Iraq (Report Number SIGIR-PA-06-039)

## **Zakho Military Academy, Zakho, Iraq**

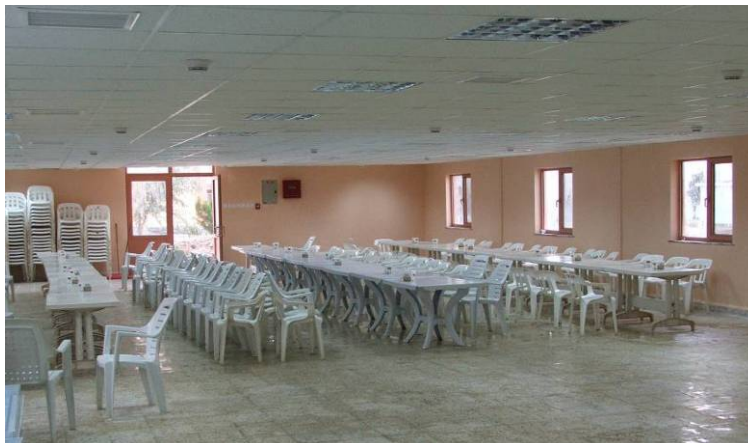
The facility had been turned over to the military academy in December 2005. Site Photo 1 shows the interior of the dining area in the renovated facility between the morning and afternoon meals. The interior of the facility appeared to meet the requirements of the task order except for some minor moisture damage in one small wall area which the USACE QAR was following up on for repair.

**Site Photo 1. Interior of renovated dining facility, Bldg. 1090**

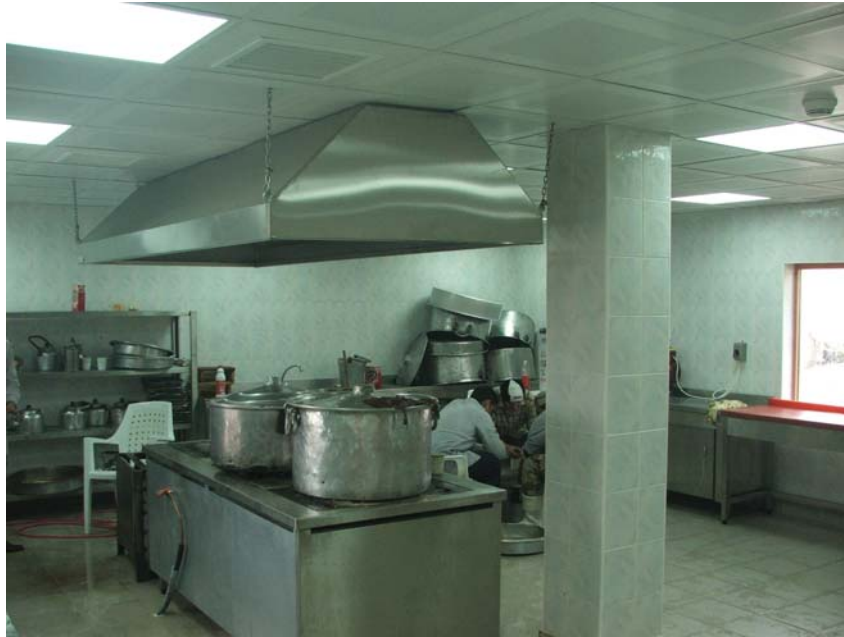
In addition to the renovation of the kitchen area, the Task Order required the procurement and installation of 14 new items of kitchen equipment. Major items included a service counter, a stove, and an industrial refrigerator. Site Photo 2 shows the location of the stove and exhaust hood in the kitchen. We did not take an inventory of the 14 items, but the kitchen appeared to be fully functional with an oven, stove, sinks, refrigerator, food preparation and storage areas.

**Site Photo 2. Kitchen in Bldg. 1090**

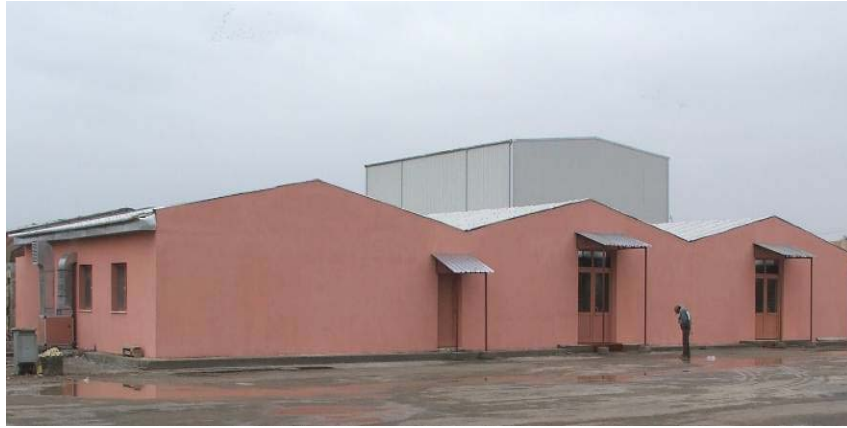
We were not able to inspect the interior of the building because of time constraints, but the facility had been in operation since the end of August 2005, when it was turned over to the military academy for its use. We did examine the exterior and did not find any noticeable defects associated with the exterior finishes or roof. Site Photo 3 shows the exterior of the building with the painted cement stucco finish.

**Site Photo 3. Exterior of renovated dining facility (Bldg. 1060)**

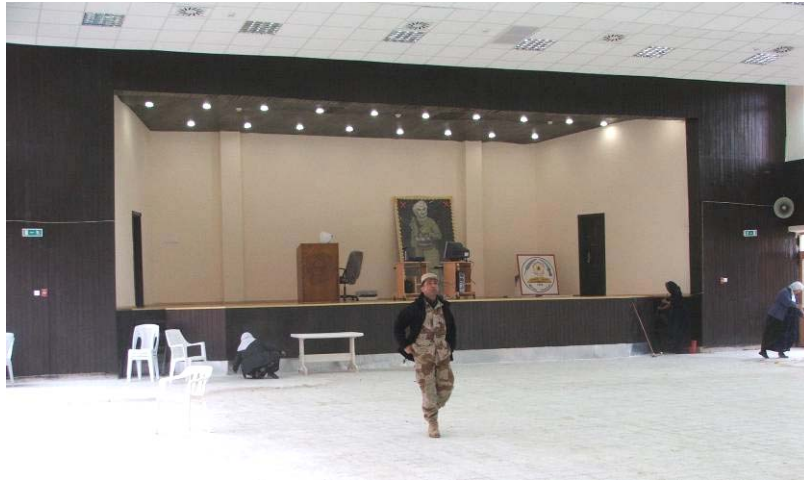
In addition to the finishes described above, the auditorium (Site Photo 5) included a new suspended acoustical tile ceiling, central air conditioning, and a stage with new wood flooring.

**Site Photo 5. Auditorium in the training building**

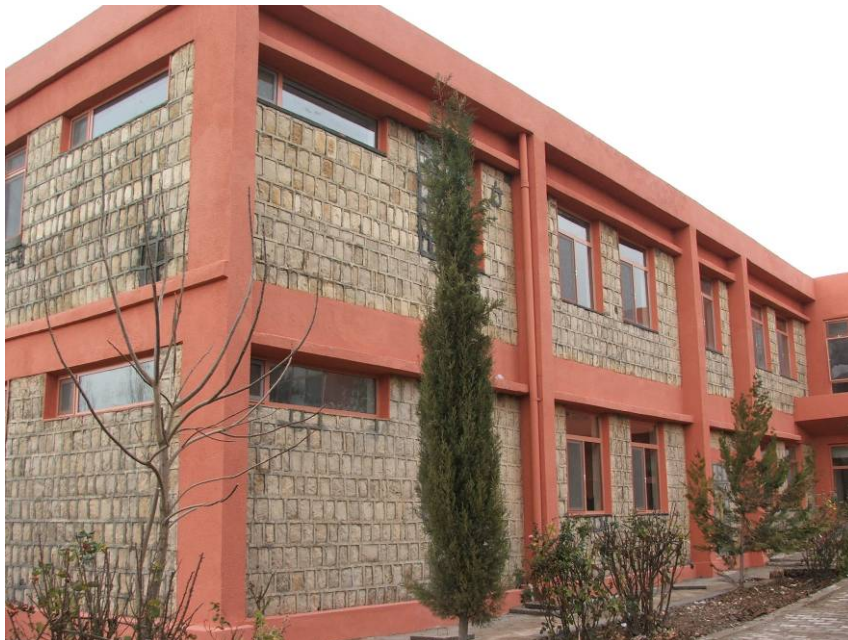
Required exterior work on the building included repair of holes, cracks and expansion joints, as well as cleaning of exterior surfaces and painting. The contractor also replaced the roof by removing the existing concrete panels and installing new waterproofing material, insulation, and gravel ballast. Site Photo 6 shows the exterior of one wing of the training building after the repairs, cleaning and painting.

**Site Photo 6. Exterior view one wing of the training building**

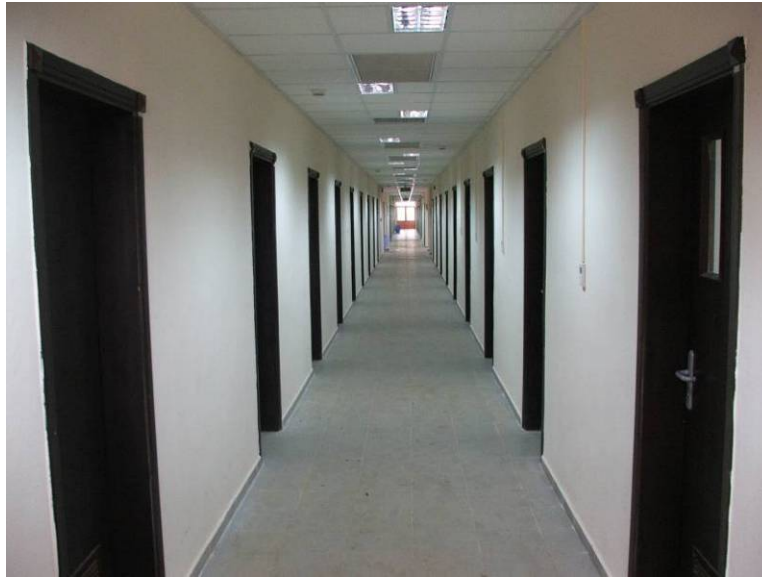
block walls. The building design included centrally located latrines, a laundry, and a lounge on both floors, flanked by student rooms in each wing. The barracks contained 76 rooms for student billeting, with each barracks room approximately 3 m wide by 4.8 m long. Finished rooms included painted gypsum plastered walls and suspended acoustical tile ceilings with granite tile floors. Site Photo 7 shows the barracks first floor hallway. Site Photo 8 is an exterior view of the barracks.

**Site Photo 7. Interior hallway on first floor of the barracks**

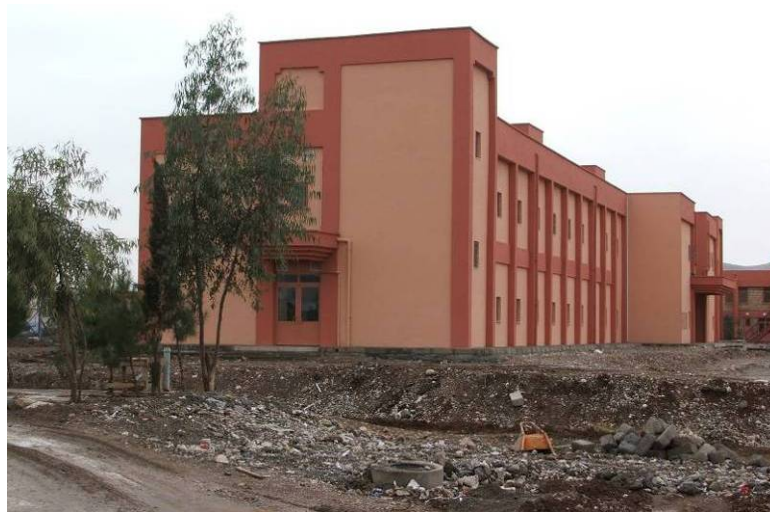
**Site Photo 8. Exterior of new barracks facility**

Based on the review of the contract requirements, the design, and our observations on site, the construction of the barracks met the requirements of the contract. However, since our site visit was in January, which typically is a wet month, the grounds of the military academy were muddy and there was a great deal of standing water. The construction around the academy exacerbated these problems. Since there were few sidewalks interconnecting buildings, there were few places to walk between buildings without having to walk in the mud. As a result, a large amount of mud was being tracked inside the barracks, particularly into the latrines.

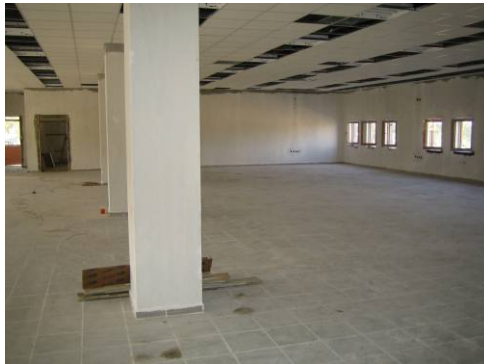
The Task Order required the design and construction of a one-story reinforced concrete and concrete block building – approximately 1,500 m<sup>2</sup> with a cement-stucco exterior and interior office space. The design included open administrative space, conference rooms, latrines, a central roof-mounted HVAC system augmented by separate split HVAC units for the conference rooms, 240 volt/50 Hertz power, communications wiring, and interior finishes (gypsum plaster painted walls, granite tile floors, and suspended acoustical ceiling). Site Photo 9 taken in November 2005, shows one of the administrative areas still under construction and Site Photo 10 shows the completed administrative area at the time of our site visit. The building was not yet occupied, but was essentially complete, except for correction of punch list items. The outfitting of the facility with free standing and modular furniture was the responsibility of the military academy.

**Site Photo 9. Administrative space under construction – Photo provided by MNSTC-I**

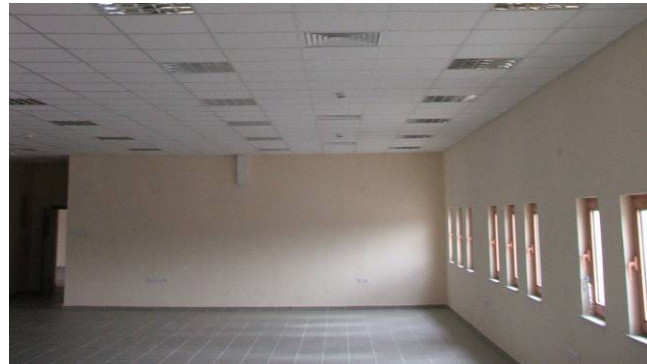
**Site Photo 10. Completed administrative space**

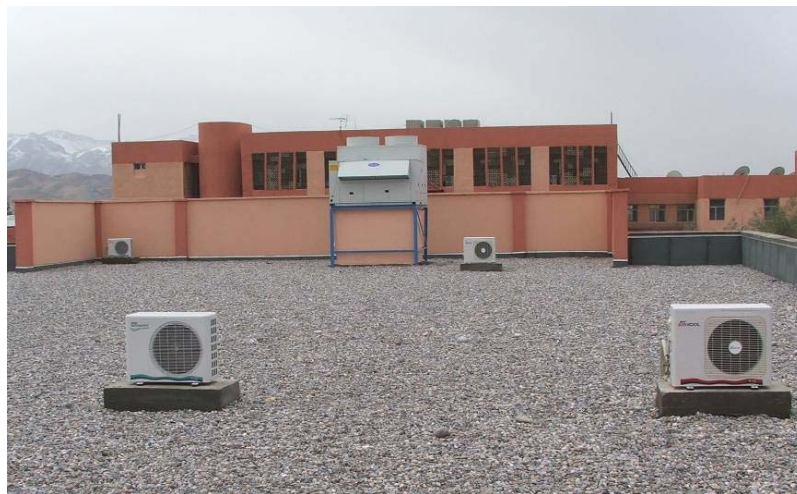
In addition to inspecting the interior, we also checked the roof. The built-up roof consisted of a layer of polystyrene heat insulation over two layers of waterproofing membrane that was placed over the reinforced concrete roof slab. The polystyrene insulation was topped with a layer of gravel ballast. The roof was sloped to drain outward to roof drains. Even though it had rained recently, there was no standing water at any location on the roof. The HVAC units were also located on the headquarters building roof. Site Photo 11 shows the combination of split system condensing units and the central Carrier HVAC unit.

**Site Photo 11. Headquarters building roof with roof-top HVAC units**

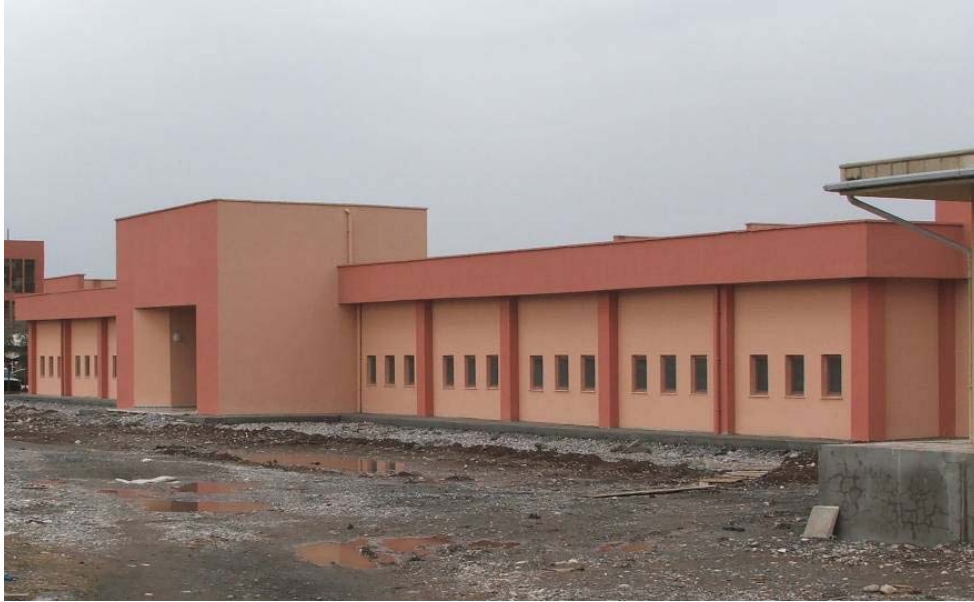
The architectural style of the headquarters building is similar to the barracks. As shown in Site Photo 12, the structural concrete frame of the headquarters building was infilled with concrete block walls and covered with a painted cement-stucco finish. The color scheme of the headquarters building matched the exterior color scheme of the barracks, as well as the two dining facilities and the training building.

**Site Photo 12. Exterior view of the headquarters building**

The completed construction of the headquarters building met the requirements of the Task Order. There were no noticeable defects in the interior finishes and with the exterior of the building, including the roof.

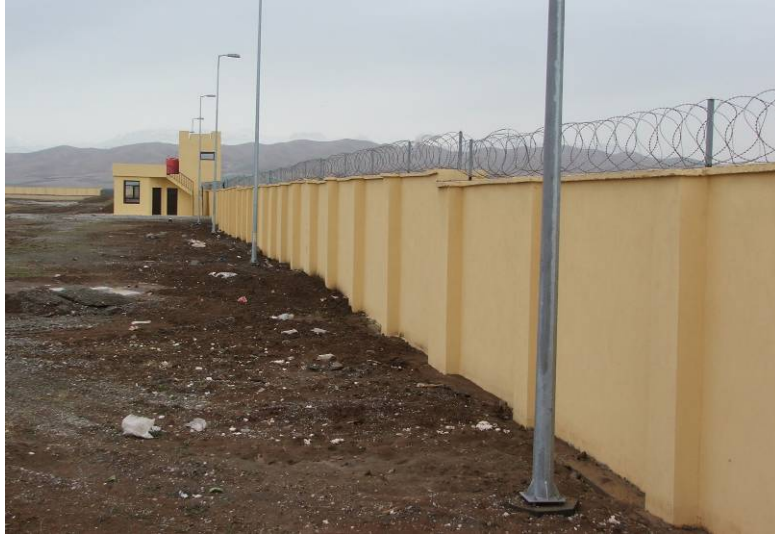
Although we did not inspect the entire perimeter wall, we did examine the wall at several locations, which included one gate near the wastewater treatment plant. The sections of wall that we inspected met the requirements of the design and specifications. Site Photo 13 shows the perimeter wall along the north side of the academy. Also shown in the photo is one of the guardhouses, which was built under another contract and not part of our assessment. Site Photo 14 shows one of the sliding gates in operation along the east side of the academy.

**Site Photo 13. The perimeter wall along the north part of the Military Academy**

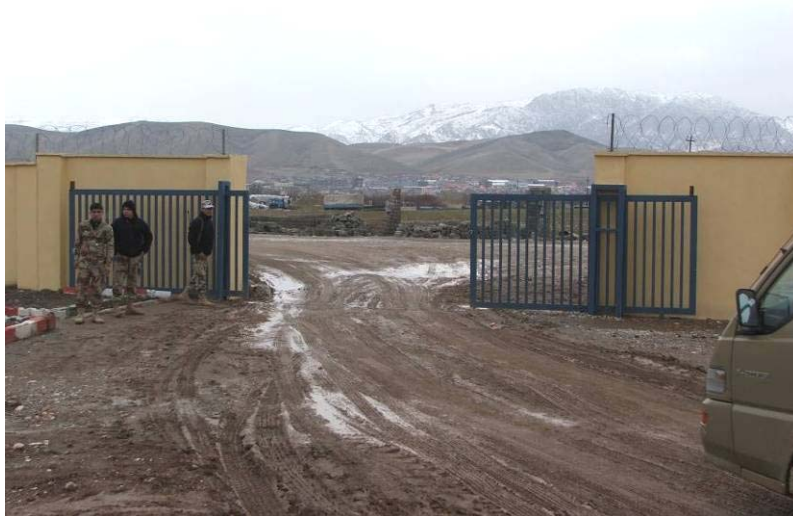
In addition to the perimeter wall, the Task Order required the gates at two locations to be 20 feet, double wide sliding metal gates. At the time of our assessment, the construction of the perimeter wall and the two gates was complete.

**Site Photo 14. Sliding gate along the east wall of the military academy**

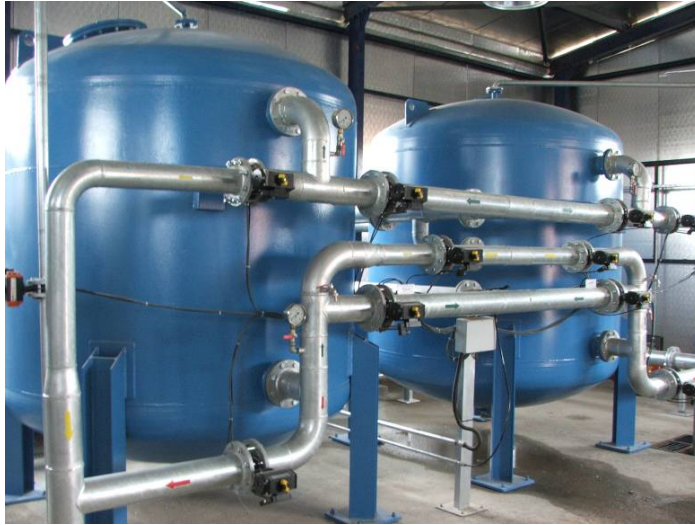
At the time of our assessment, the construction of the WTP was complete and all equipment installed. The pumps, filtration units, and RO units were housed in a pre-engineered metal building constructed by the contractor. Site Photo 15 shows the tanks containing the 15 micron (quartz sand/anthracite/activated carbon) filter system and Site Photo 16 shows the pressure vessels containing the RO thin film membrane elements.

**Site Photo 15. Tanks enclosing the 15 micron filters**

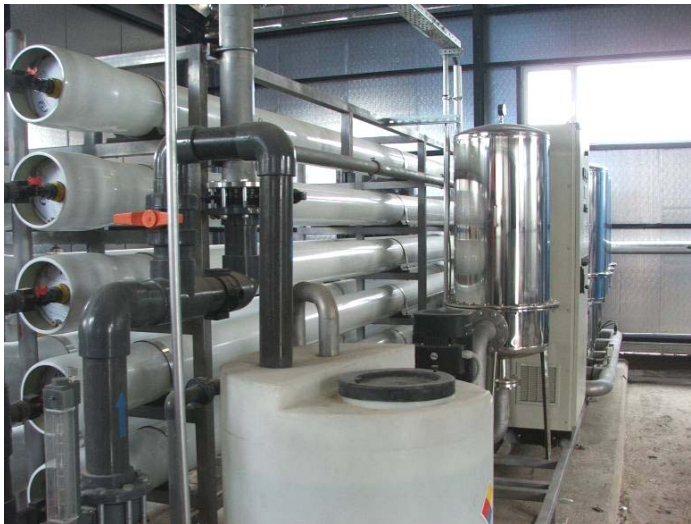
**Site Photo 16. Reverse osmosis purification units**

Although the WTP components were in place and interconnected according to the design and specifications, the treatment plant was not yet operating. The commissioning and start-up of the WTP, as well as the new wastewater treatment plant (WWTP), were contingent on the completion of electrical power upgrades being made to the academy under a separate USACE contract (W917ER-05-C-

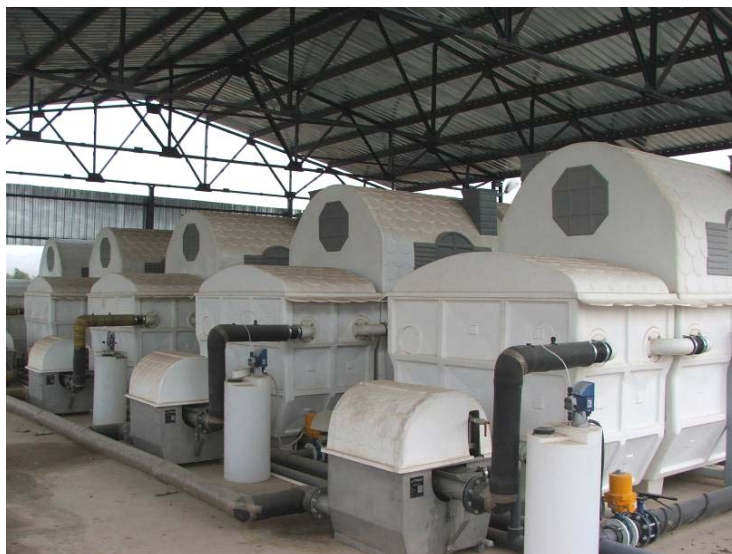
The Task Order design specifications required the installation of a new packaged wastewater treatment facility with design flow requirements of 1,000,000 lpd. At the beginning of the wastewater treatment cycle, the design called for an underground reinforced concrete flow equalization tank (200,000 liters). The purpose of the tank was to regulate flow through the WWTP by storing excess wastewater during flow surges that may be incurred during peak flow times. The specifications also required the installation of Rotating Biological Contactor (RBC) domestic wastewater treatment units to serve as the main treatment mechanism. To separate coarse materials from the influent before entering the RBCs, the design also required a baffled sedimentation tank. Other major components incorporated into the design included a final settlement tank (for sludge removal), a sludge disposal tank, a chlorination unit (for disinfection), a filtrated water tank, and a control panel. At the time of our assessment, the installation of the WWTP was complete. However, the plant had not been commissioned and turned over to the military academy for operation because USACE was waiting on the completion of the electrical generation and distribution contract. Site Photo 17 shows the WWTP package RBC units. There are five separate RBCs which are designed to operate in parallel or in series. The WWTP is also covered by a sheet metal roof that is supported by a series of steel trusses, girders, and columns.

The equalization, final settlement, filtrated water, and the sludge disposal tanks are underground, constructed below the RBCs, so we did not inspect them. Although the plant was not yet operational, the components we observed appeared to be installed according to the design and specifications. We did not see any defects in the RBC units or with the above ground piping and piping connections.

**Site Photo 17. Five RBC units for treating domestic wastewater at the WWTP**

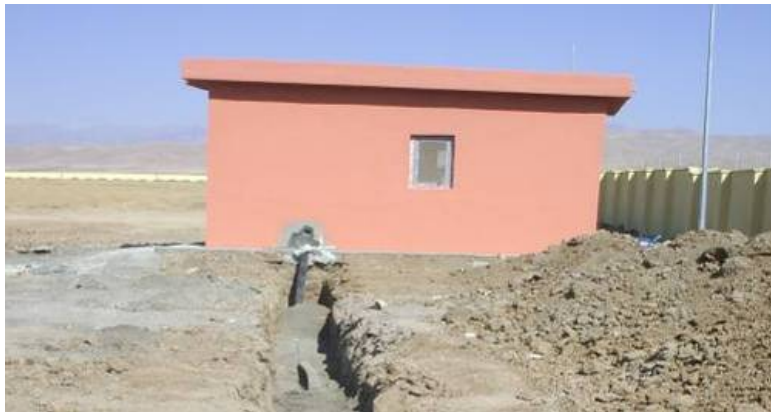
This facility was added by modification to the original Task Order and required the contractor to design and construct a new deep well and pump house, and to construct supply water lines to an existing elevated water storage tank adjacent to the new WTP. The well (drilled to a depth of 150 m), well house, and piping to the existing elevated water storage tank were completed in October 2005. Site Photo 18 taken during the construction, shows the well house, as well as the excavation and backfill for the water line installation.

**Site Photo 18. Water main installation from new well house – Photo provided by USACE**

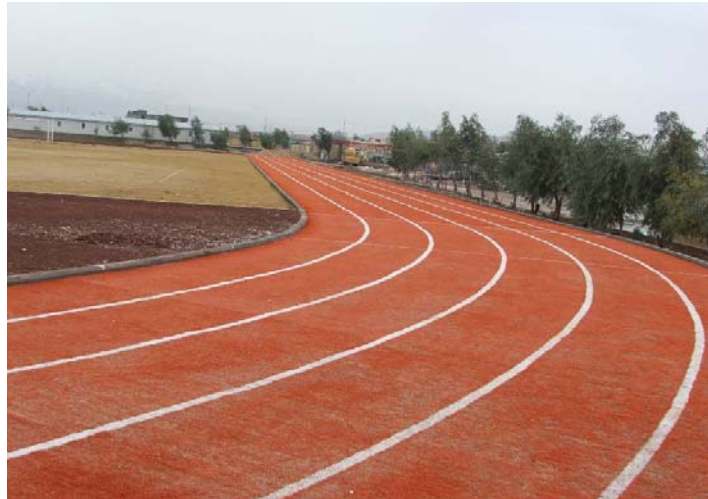
The track and soccer field construction was completed and turned over to the military academy in December 2005. When we toured the area and checked the track, we did not find any problems associated with the construction. The track was level, marked properly with stripped lanes, and free of bumps, rips, or other defects in the surface. Site Photo 19 shows the track and one half of the soccer field.

The soccer field was sodded in September 2005 and appeared to drain well. There was no standing water. The grass was dormant because of the colder winter weather in Zakho, but a review of QAR's progress photos indicate the sod was placed properly and irrigated prior to the winter months.

**Site Photo 19. Synthetic track surface on the outside of the soccer field**

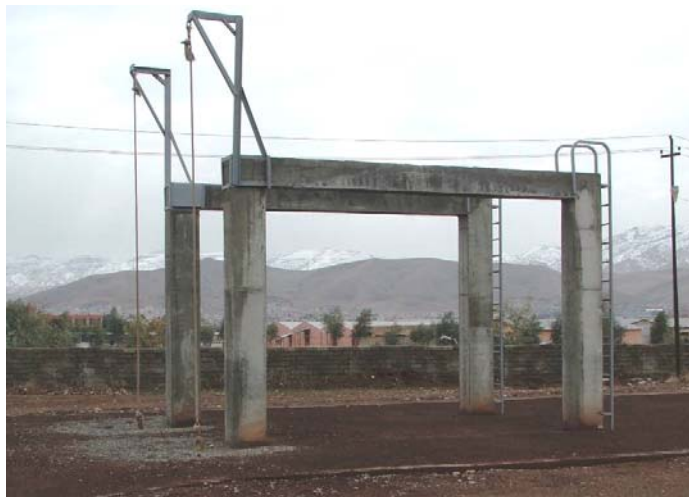
The Task Order design and specifications required a horseshoe shaped course, 350-400 m long, containing 16 obstacles, such as an inclined wall, a balance beam, a rope bridge, etc. The obstacle course construction was completed and turned over to the military academy in October 2005. We toured the site during our assessment. Sixteen obstacles were in place along a horseshoe shaped course. All appeared to be in serviceable condition. Site Photo 20 shows one of the 16 obstacles, the “double high bridge.”

**Site Photo 20. Obstacle #8 along the course – “Double High Bridge”**

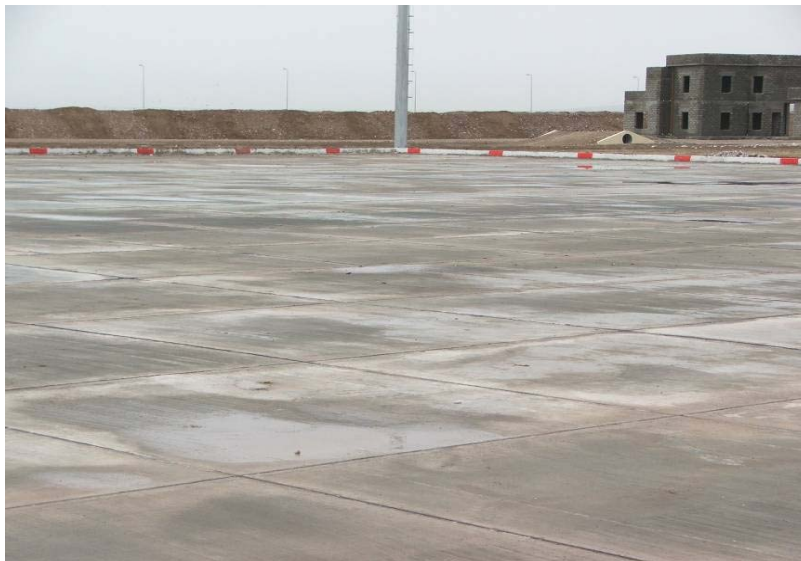
Construction of the entire project, including the stadium lighting, was completed in November 2005. Site Photo 21 shows a portion of the concrete parade field observed during our assessment. In Site Photo 22, a corner light post with four sodium vapor and two metal halide luminaries is shown.

**Site Photo 21. Concrete parade field**

We found the quality of the concrete workmanship on the paved parade field to be good. The surface was uniform, free from any noticeable cracking or other defects. The expansion joints were in place and cut according to the design. The lighting system layout was also according to design. The lighting system was not tested during our assessment, but the QAR did test and operate it for the final inspection.

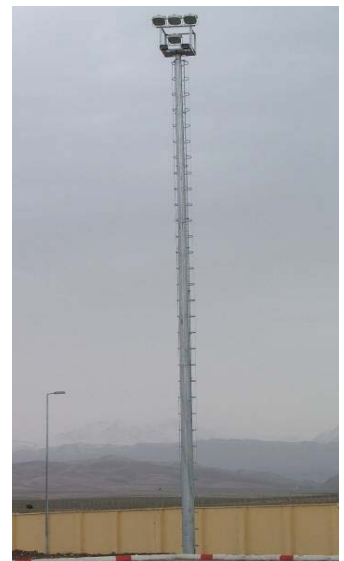
The design for the lighting system included six galvanized metal poles, 25 m high. Four of the six were corner poles and the two others were placed in the middle of each long side (110 m) of the parade field. The design for the light fixtures called for 1000 watt sodium vapor luminaries, four mounted at the top of the corner poles and five mounted on the top of the middle poles. In addition, the design required two 1000 watt metal halide luminaries on each pole in order to have pre-lighting of the parade field before the sodium vapor luminaries could fully illuminate.<sup>3</sup>

**Site Photo 22. Light Post**

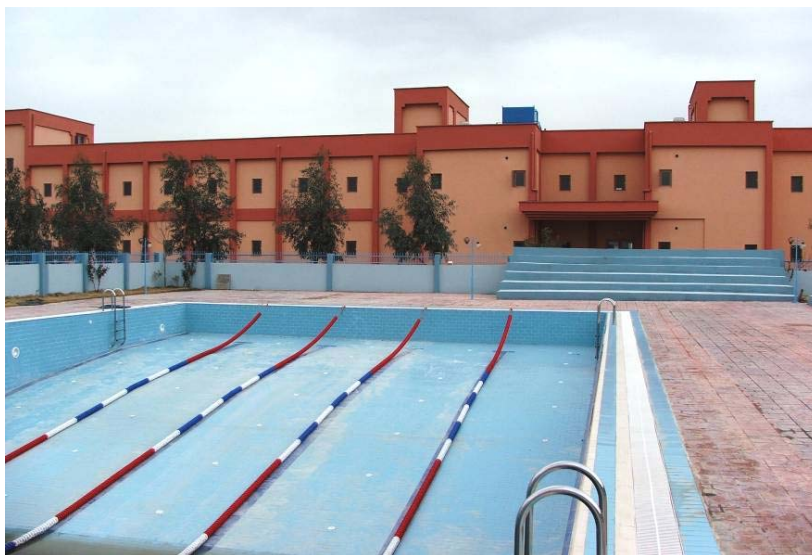
The swimming pool portion of the work was completed in November 2005. The pool at the time of our assessment was drained except for surface water accumulation at one end of the pool as shown in Site Photo 23. The swimming pool finish work appeared to meet the requirements of the Task Order. Further, the quality of workmanship was good. The gutters were constructed alongside the pool waters and covered with a protective screening material. The tiles were in place, properly positioned, and grouted. Lane markings and waterproof light fixtures were also installed according to the design requirements.

**Site Photo 23. Swimming pool and the new barracks**
